# Manhole Inspection Summary

Manhole # S190\_\_001MH

Insp Date: **3/14/08 1:16 PM**

**Location** Address: **2101s pulaski-s smallwood alley**

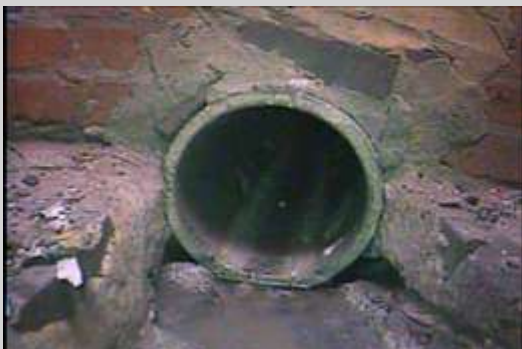
4 O'Clock Inflow

8 in. Circular Gravity Sewer  
Pipe In @ 4 O'Clock

Pipe Height: **8.4** (in.) Rod and Bar (Angled)  
Pipe Material: **Clay** ☐ Pipe Lined  
Invert Depth: **6.80** (ft.) Flow Characteristics: **Slow**  
Deposits: ☒ None ☐ Mud ☐ Sludge ☐ Debris ☐ Grease  
Silt Depth: **0** (in.) Deposits Extent:  
Infiltration: **None** Pipe Seal Cond: **Sound**

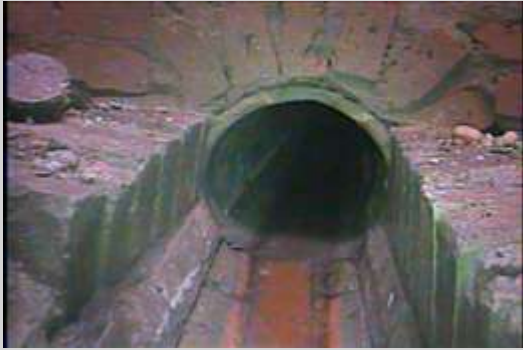
6 O'Clock Inflow

8 in. Circular Gravity Sewer

Pipe In @ 6 O'Clock

Pipe Height: **8.4** (in.) Rod and Bar (Angled)

Pipe Material: **Clay** ☐ Pipe Lined

Infiltration: **None** Pipe Seal Cond: **Sound**
